Manhole Inspection Summary

Manhole # S41EE_009MH

Insp Date: **1/9/08 12:28 PM**

Location Address: **1219 E CHASE ST**

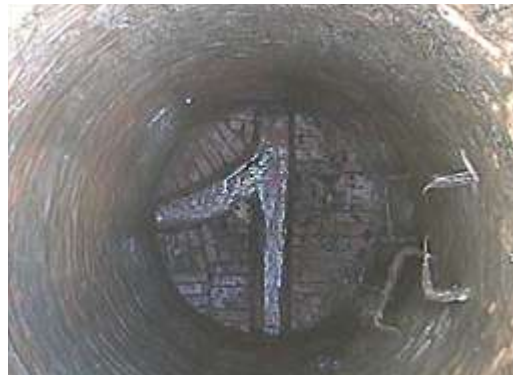
Defect 2

Count: **5** Missing: **2** ☒ **Corroded**

STEPS CORRODED

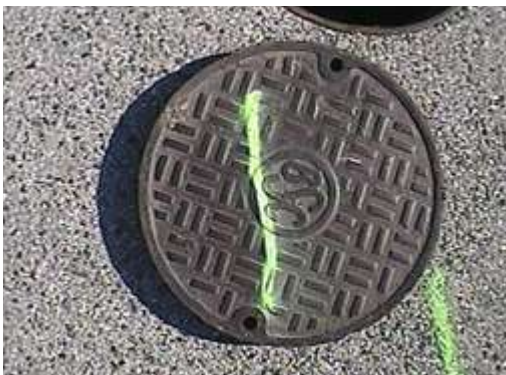
Defect 1

Condition: **Cracked**

CRACKED COVER

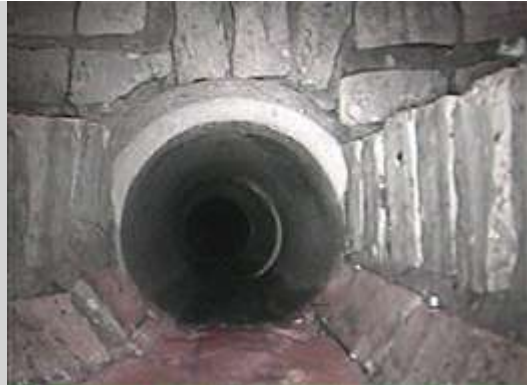
12 O'Clock Outflow

8 in. Circular Gravity Sewer
Pipe Out @ 12 O'Clock

Infiltration: **None** Pipe Seal Cond: **Sound**

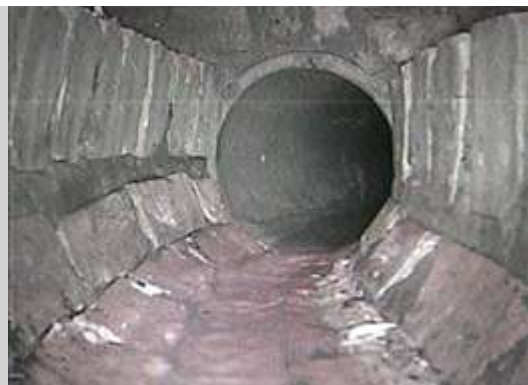
9 O'Clock Inflow

Infiltration: **None** Pipe Seal Cond: **Sound**
